# THE MOLD COVER UP

A very disturbing trend...

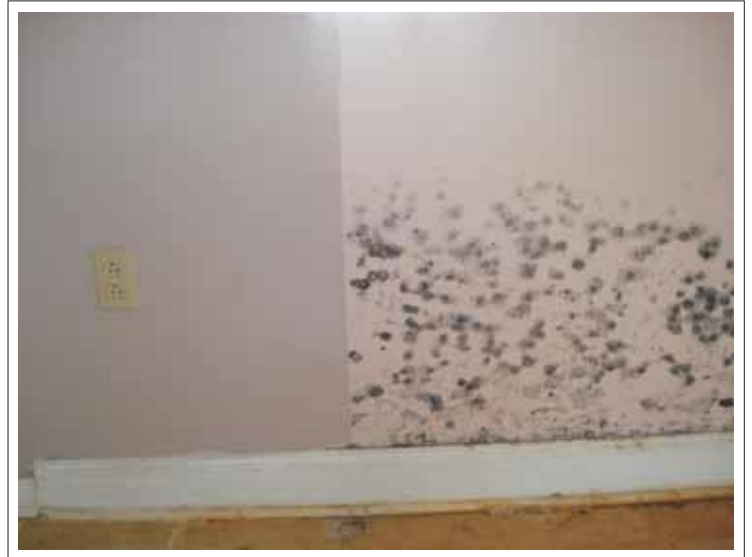
During a recent mold inspection, we ran across this (all too common) condition.,,mold painted over! In this situation it was the bank who foreclosed on this home and sent out their handymen to make the house look good so it can be quickly put back on the market for resale.

We happened to show up while the “clean up/remediators/\$5.00 an hour crew” was at lunch and found they were painting over the mold on the walls. They didn’t even take the time to wipe the heavy growth off - they just painted over it.

The problem is that this mold will continue to grow under the paint and in about 6 to 8 months start to come through the paint again. But by then it becomes the new homeowners responsibility, there's no one to go back on because it was not found prior to the purchase. The other problem is as a mold inspector and tester...we can not easily identify these conditions exist. Once painted over the mold is no longer visible, will not show up on a lift tape or swab test, nor will these mold spores be airborne for testing. A mold contractor can not be held responsible for not finding these conditions.
